## CASE STUDY: POLISHING OF AN MTBE HOT ZONE IN LOW PERMEABILITY ARTIFICIAL FILL AFTER PUMP AND TREAT

RE: Christina School District  
Maintenance and Operations Facility  
200 Salem Church Road  
Newark, DE 19713

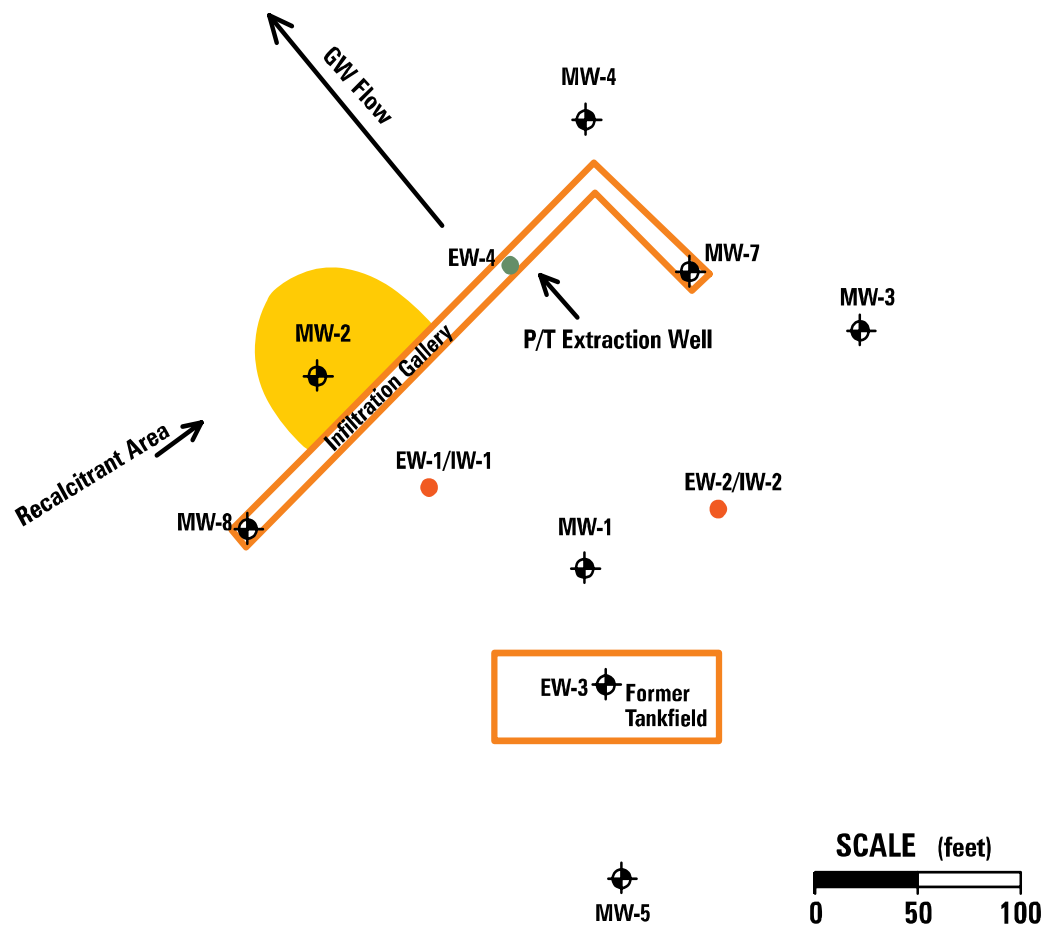
### SITE PLAN

- Pump and Treat system operated for 3 years.
- Groundwater in isolated portions of the site remained significantly above cleanup levels for MTBE.
- 2 iSOC<sup>®</sup>s used for 1 year upgradient of MW-2 and sidegradient and slightly downgradient of MW-1.
- MTBE levels were drastically reduced at MW-1 and MW-2: cleanup criteria were met.
- iSOC<sup>®</sup> system removed.
- Site is closed. A No Further Action letter was issued by the Department of Natural Resources and Environmental Control.

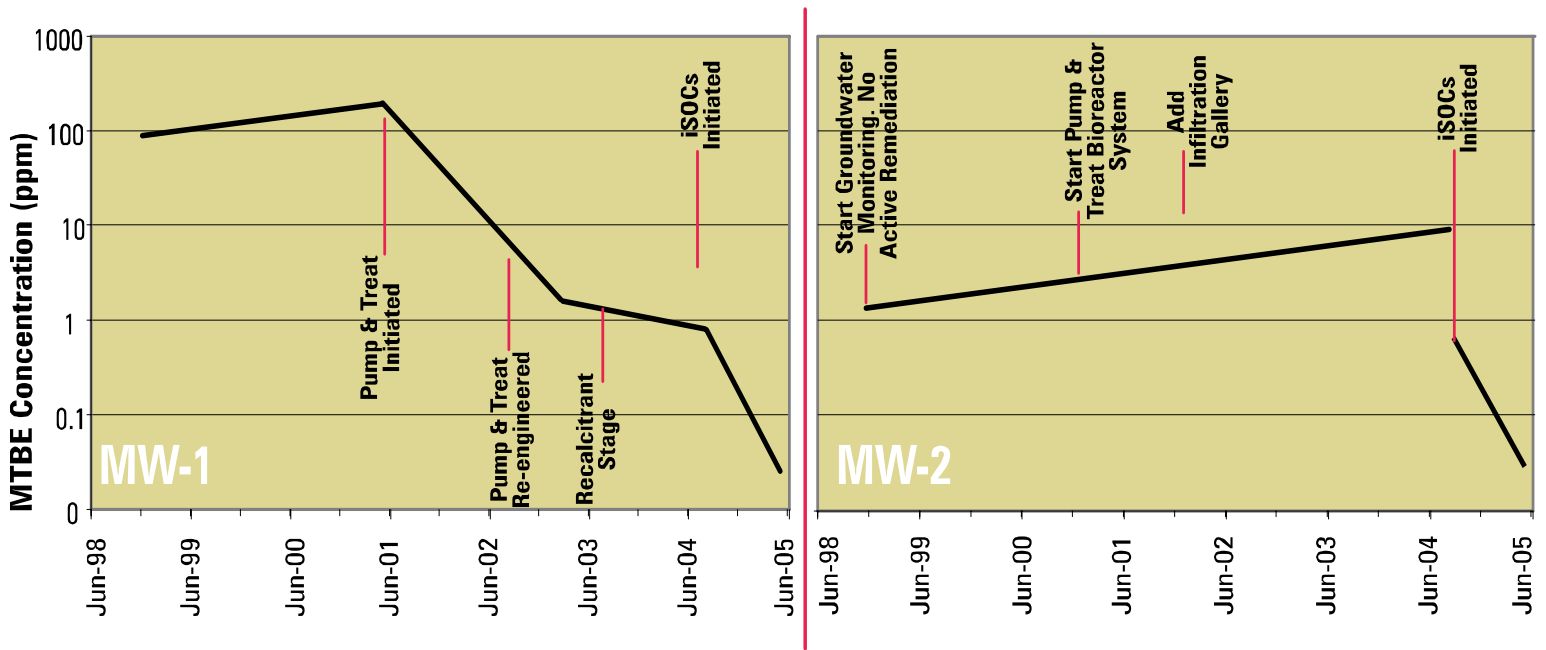
# MTBE GROUNDWATER REMEDIATION RESULTS

Other representative MTBE levels were 35,000 ppb, 22,000 ppb, and 7,000 ppb for monitoring points MW-4, EW-3 and MW-2. After three years of pump and treat, MTBE levels at MW-1, MW-4, EW-3 and MW-2 were 310 ppb, 49 ppb, Non Detect (ND), and 1,040 ppb respectively. These results illustrate limitations of a pump and treat system for treatment locations with extreme heterogeneous soil conditions. Areas with porous soils clean up readily but groundwater contamination in tight soil conditions often proves to be difficult to remediate.

This DE high school site demonstrates that implementation of strategically located iSOCs will effectively treat recalcitrant areas utilizing in situ, enhanced natural attenuation. After 1 year of enhanced bioremediation, the concentrations of MTBE in MW-1, MW-4, EW-3 and MW-2 were: ND, 229 ppb, 13.5 ppb and 21.5 ppb respectively.
