CASE STUDY

USE OF iSOC[®] TECHNOLOGY AT PETROLEUM TANKER SPILL

SOUTHEAST, IOWA

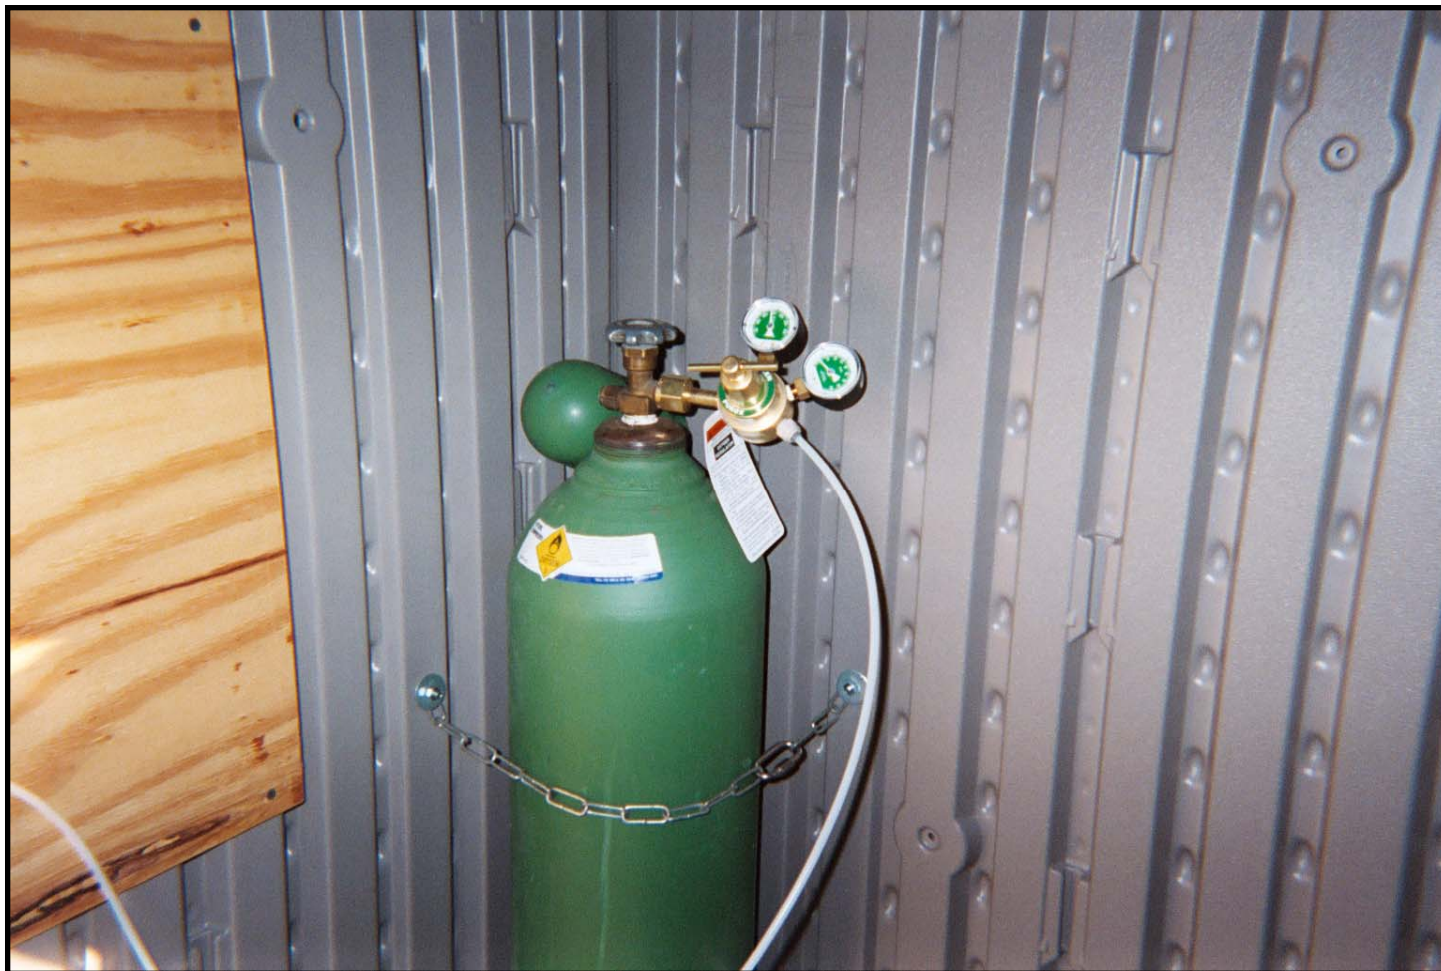
iSOC® System Gas Cylinder in the Remediation Shed

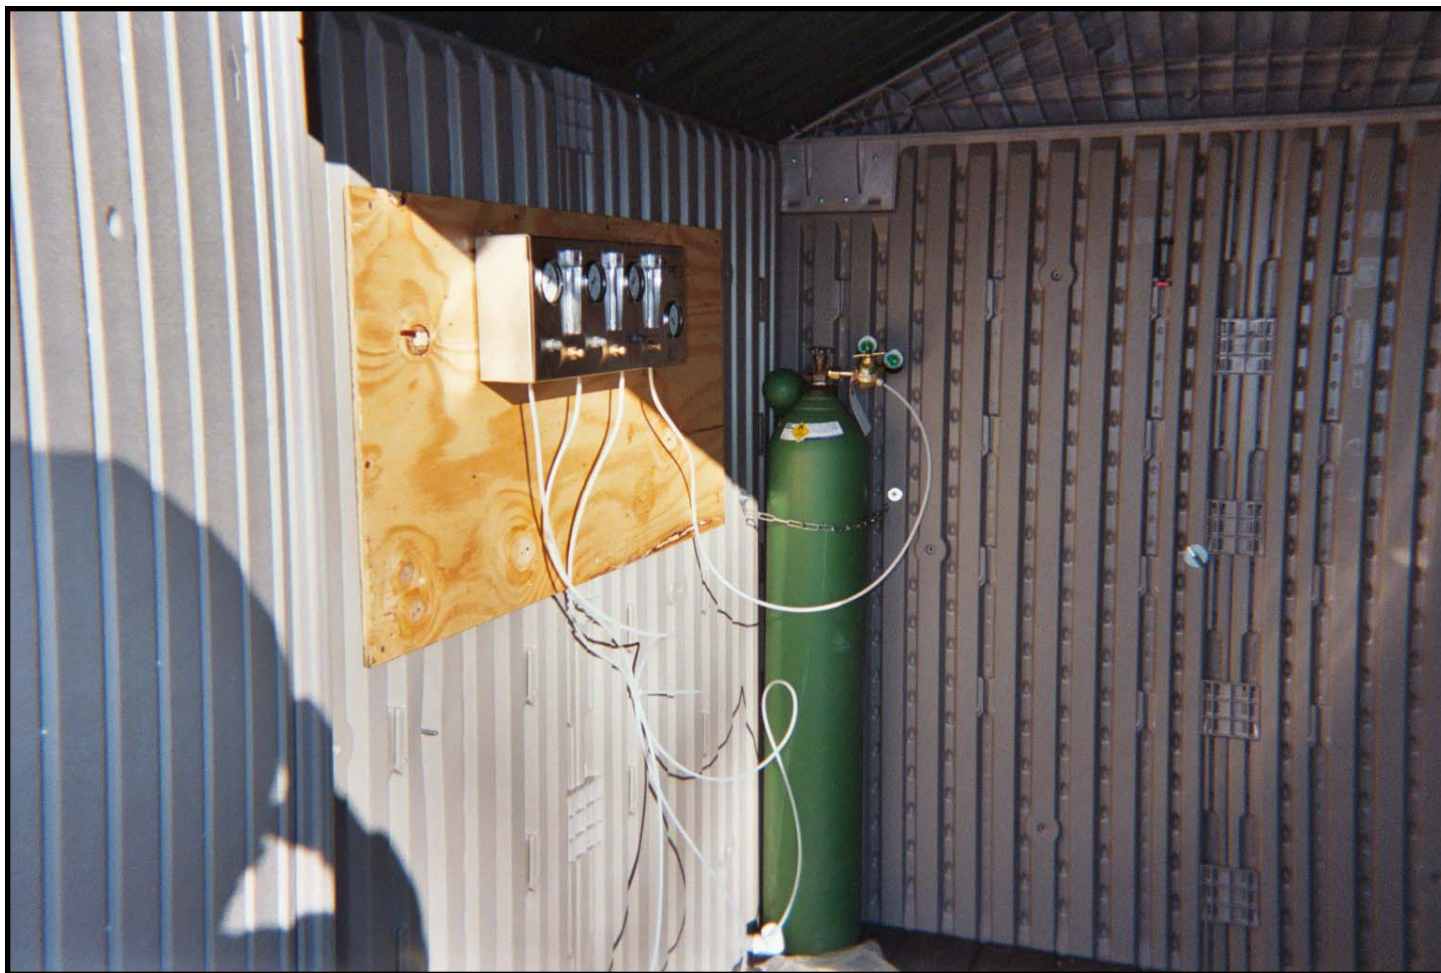
iSOC® System Control Panel in the Remediation Shed

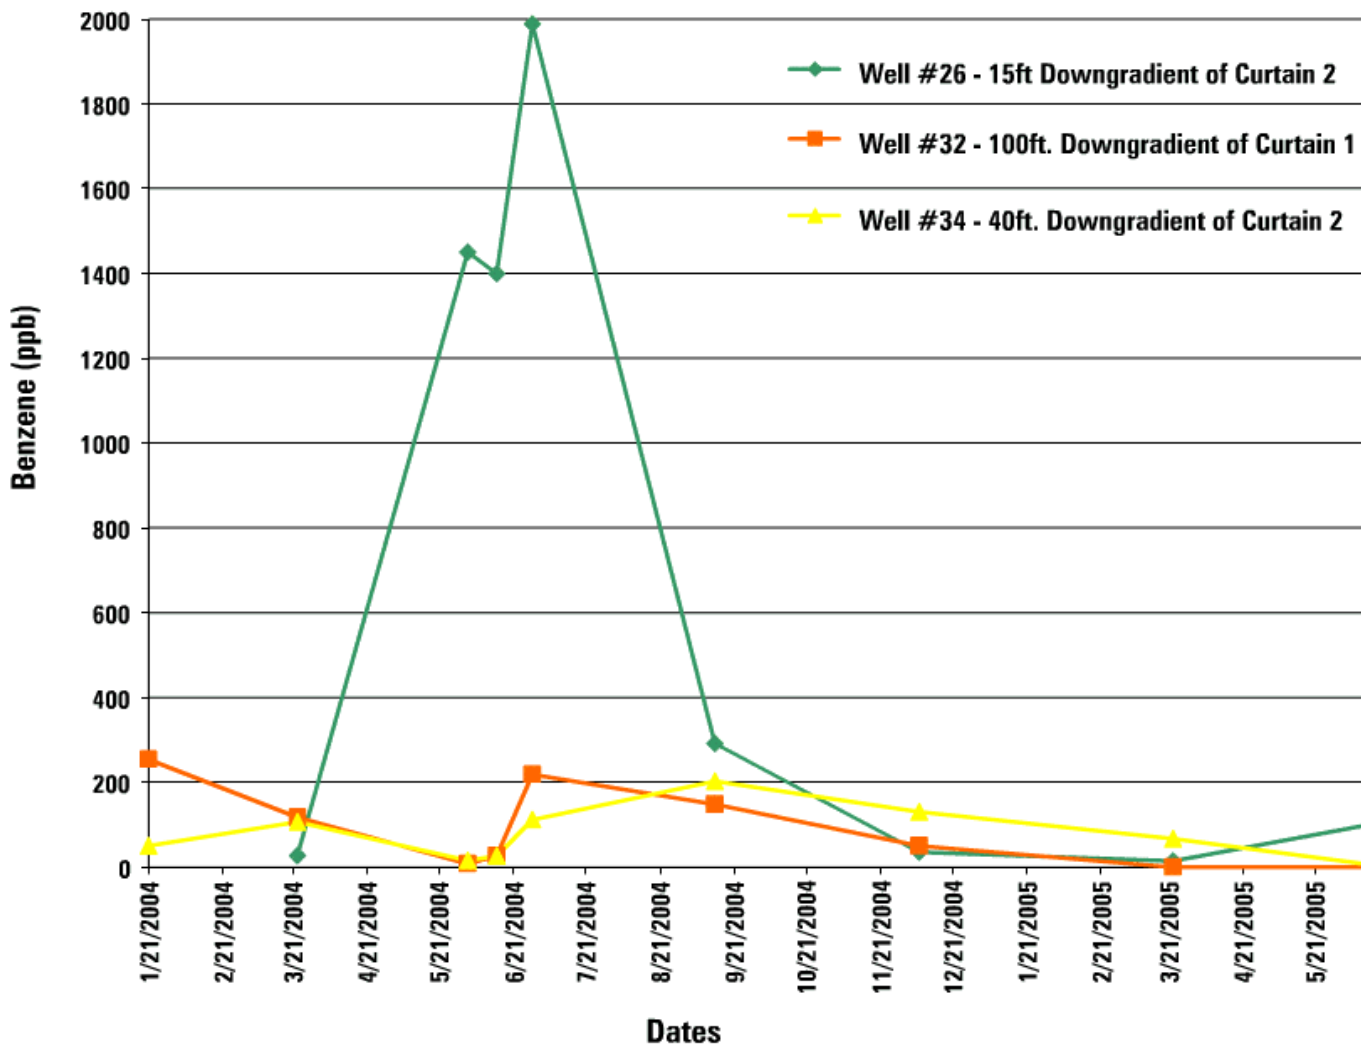
Benzene Concentrations in MW 26, MW 32 & MW 34 (Curtains 1 & 2)

Date	Benzene	Toluene	E-Benzene	Xylene	MTBE
1/30/04	254	6	<1	7	12
3/23/04	117	5	<1	BDL	6
6/2/04	8	1	<1	BDL	2
6/14/04	26	BDL	<1	BDL	3
6/29/04	219	8	<1	62	11
9/13/04	148	1	<1	5	5
12/7/04	50	2	<1	BDL	BDL
2/23/05	BDL	BDL	<1	BDL	BDL
6/16/05	BDL	BDL	<1	BDL	BDL

Date	Benzene	Toluene	E-Benzene	Xylene	MTBE
5/16/03	1150	14	6.6	15	18
10/17/03	1130	17	BDL	6	36
3/23/04	27	BDL	BDL	BDL	19
6/2/04	1450	19	BDL	15	38
6/14/04	1400	24	BDL	BDL	34
6/29/04	1990	36	BDL	12	48
9/15/04	291	4	BDL	BDL	30
12/7/04	35	BDL	BDL	BDL	7
2/23/05	14	BDL	BDL	BDL	BDL
6/16/05	104	BDL	BDL	5	BDL

Date	Benzene	Toluene	E-Benzene	Xylene	MTBE
1/21/04	50	1	BDL	BDL	7
3/23/04	107	2	BDL	BDL	7
6/2/04	16	BDL	BDL	BDL	7
6/14/04	27	BDL	BDL	BDL	9
6/29/04	112	BDL	BDL	BDL	13
9/13/04	203	BDL	BDL	BDL	16
12/7/04	131	BDL	BDL	BDL	5
3/23/05	67	BDL	BDL	BDL	BDL
6/16/05	4	BDL	BDL	BDL	BDL
